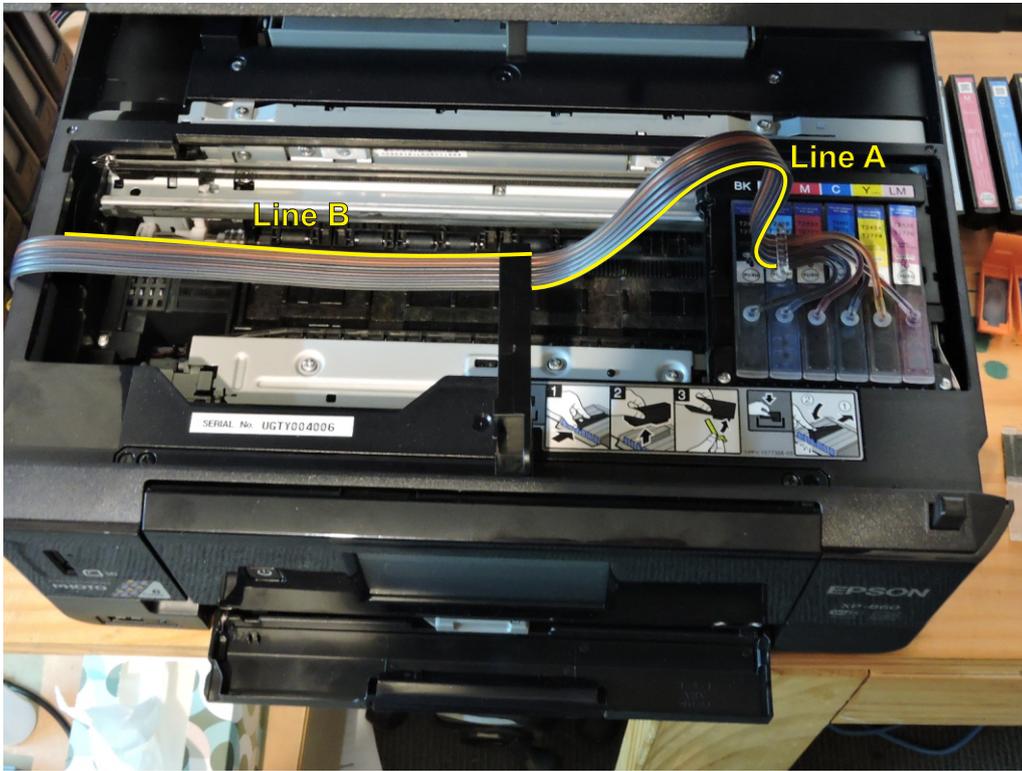
The Problem: Line A must be equal to the length of Line B. However this makes a large loop which bangs against the lid of the printer. This is vigorous enough to actually move the lid. I am sure that this would quickly destroy something, either CISS or printer.

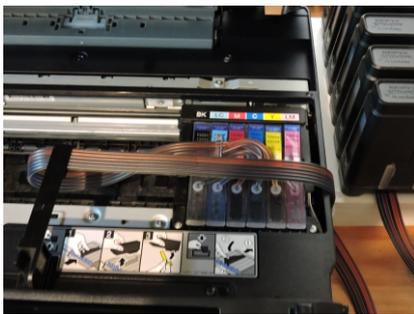
Without going through the mental processes to get there the solution was to instal the system from the right hand side rather than from the left. The loop so formed is much smaller and is easily directed by the lid in a rolling motion rather than an impact motion.

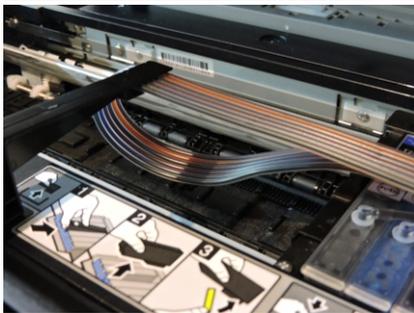
Here the "at rest" loop hangs down and doesn't touch anything.

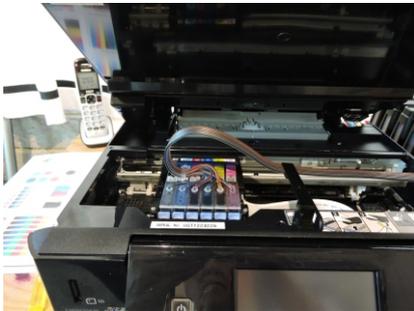
Further across its travel path the upper loop can be seen with an understanding that it rolls along the lid

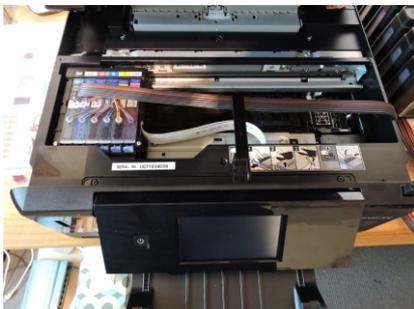
This "full stretch" position indicates that the position of the ink tube tape in the L-bracket is self determining and although critical is very simply applied.
